Manhole Inspection Summary

Manhole # S21M1_006MH

Insp Date: **5/1/08 1:38 PM**

Location Address: **2301 hollins ferry rd**

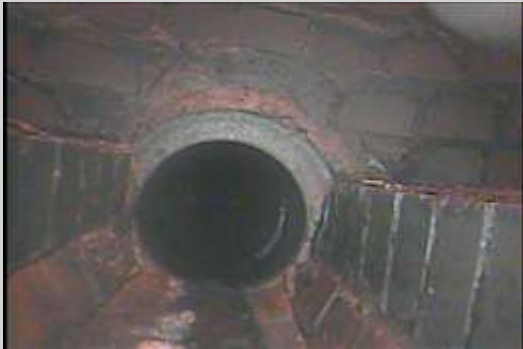
12 O'Clock Outflow

8 in. Circular Gravity Sewer
Pipe Out @ 12 O'Clock

Pipe Height: **8.4** (in.) Rod and Bar (Angled)
Pipe Material: **Clay** ☐ Pipe Lined
Invert Depth: **11.70** (ft.) Flow Characteristics: **Slow**
Deposits: ☒ None ☐ Mud ☐ Sludge ☐ Debris ☐ Grease
Silt Depth: **0** (in.) Deposits Extent:
Infiltration: **None** Pipe Seal Cond: **Sound**

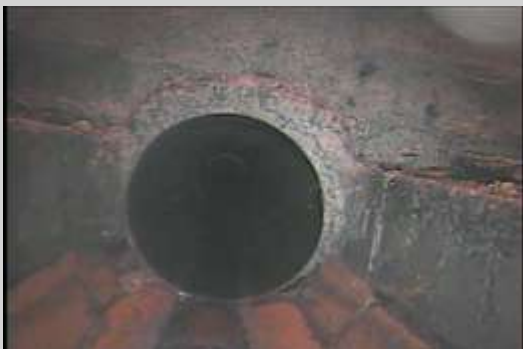
6 O'Clock Inflow

8 in. Circular Gravity Sewer
Pipe In @ 6 O'Clock

Pipe Height: **8.4** (in.) Rod and Bar (Angled)
Pipe Material: **Clay** ☐ Pipe Lined
Invert Depth: **11.55** (ft.) Flow Characteristics: **Slow**
Deposits: ☒ None ☐ Mud ☐ Sludge ☐ Debris ☐ Grease
Silt Depth: **0** (in.) Deposits Extent:
Infiltration: **None** Pipe Seal Cond: **Sound**
